IA-32 Intel[®] Architecture Software Developer's Manual

Documentation Changes

September 2003

Document Number: 252046-005

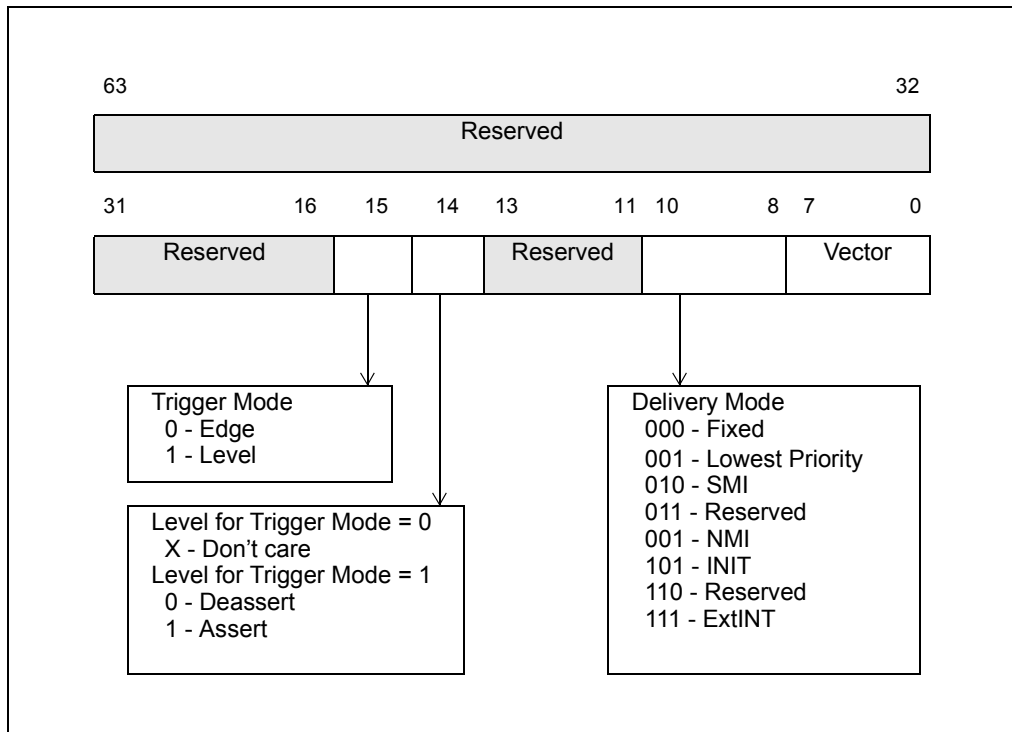
Figure 8-24. Layout of the MSI Message Data Register

ExINT should be ExtINT in Figure 8-24, located in the “Message Data Register Format” section, Chapter 8, *IA-32 Intel Architecture Software Developer's Manual, Volume 3*. The corrected figure is reproduced below.

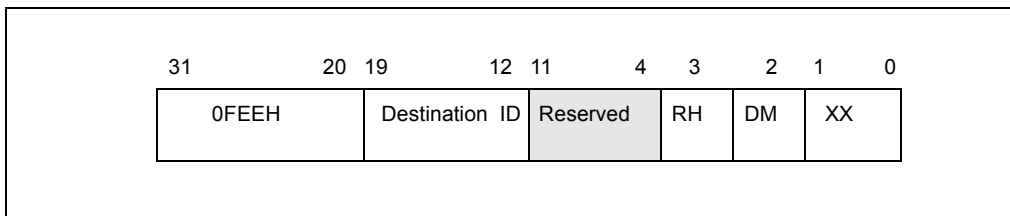
0FEEH was incorrectly represented as 0FEEEH in Figure 8-23, located the “Message Address Register Format” section, Chapter 8, *IA-32 Intel Architecture Software Developer’s Manual, Volume 3*.

The corrected figure is reproduced below.

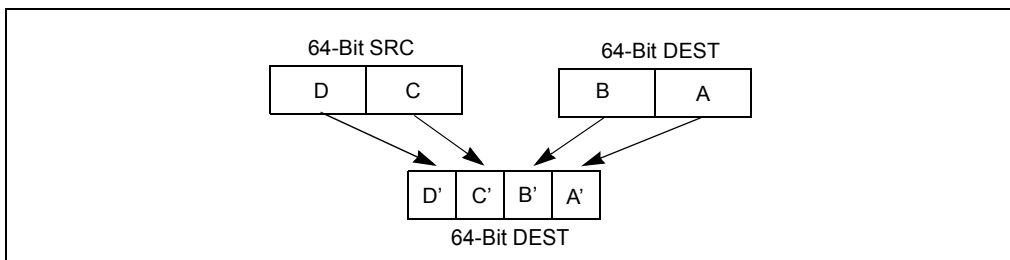
Operation of the PACKSSDW instruction was incorrectly illustrated in Figure 3-6, the “PACKSSWB/PACKSSDW—Pack with Signed Saturation” section, Chapter 3, *IA-32 Intel Architecture Software Developer’s Manual, Volume 2*.

The corrected figure is reproduced below.

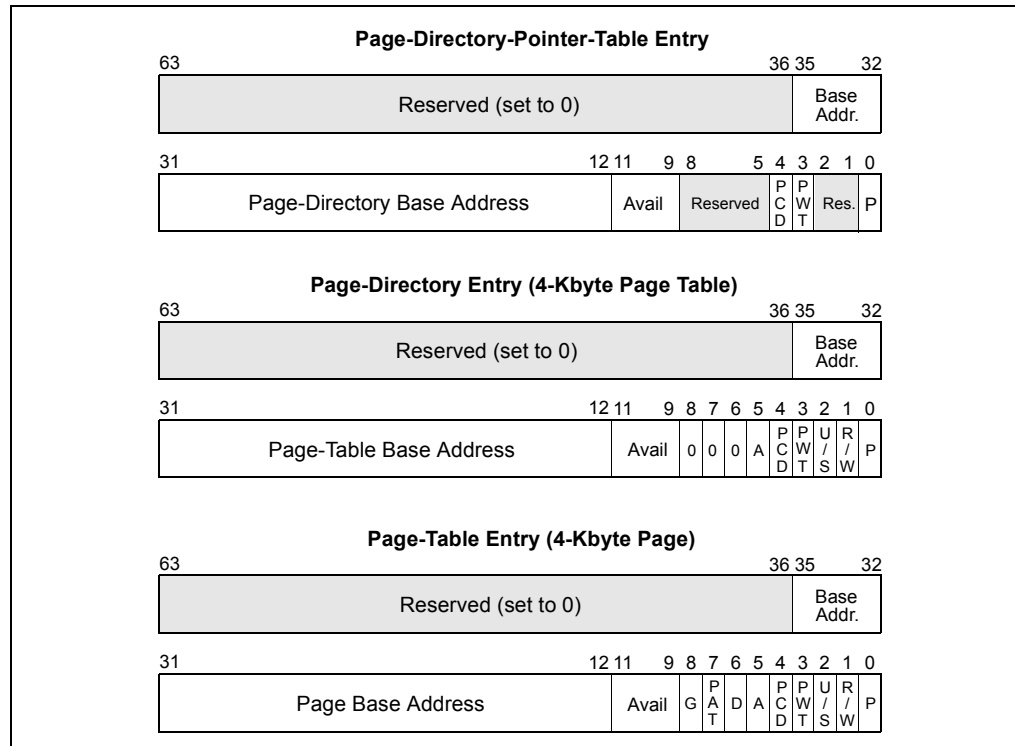
Figure 3-20. Format of Page-Directory-Pointer-Table, Page-Directory, and Page-Table Entries for 4-Kbyte Pages with PAE Enabled

In Figure 3-20 and 3-21, located in the “Page-Directory and Page-Table Entries With Extended Addressing Enabled” section, Chapter 3, *IA-32 Intel Architecture Software Developer’s Manual, Volume 3*; Bit 0 of both representations of the Page-Directory-Pointer-Table Entry now indicate P (showing the location of the ‘present flag’ bit).
